INDOOR AIR QUALITY ASSESSMENT

**West Roxbury District Court
445 Arborway
Jamaica Plain, Massachusetts**

Prepared by:
Massachusetts Department of Public Health
Bureau of Environmental Health
Indoor Air Quality Program
January 2019

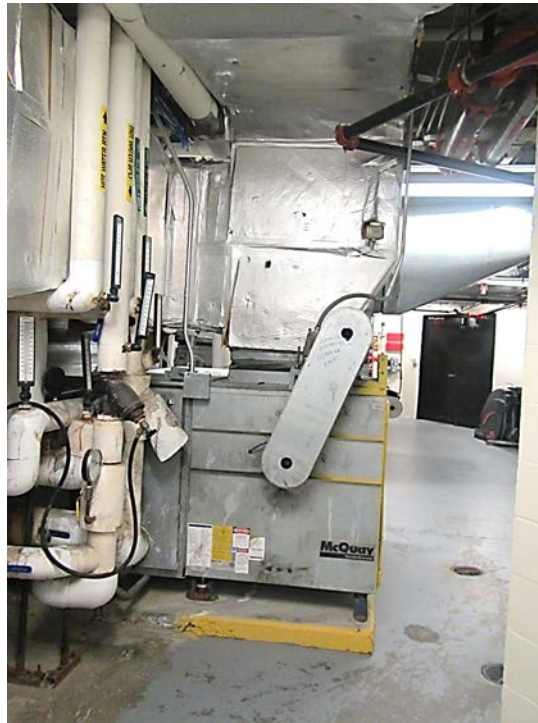
Picture 1

Air-handling units (AHUs) located in a mechanical room (Picture 1) provide fresh air to court rooms and office spaces in the WRC. AHUs are fitted with pleated filters that are changed four times a year (Picture 2). Fresh, tempered air is supplied by ceiling-mounted supply vents (Picture 3). Air is returned to AHUs via ceiling-mounted exhaust vents (Picture 4). To maximize air exchange, the MDPH recommends that both supply and exhaust ventilation operate continuously during periods of occupancy.

Air-handling unit in mechanical room

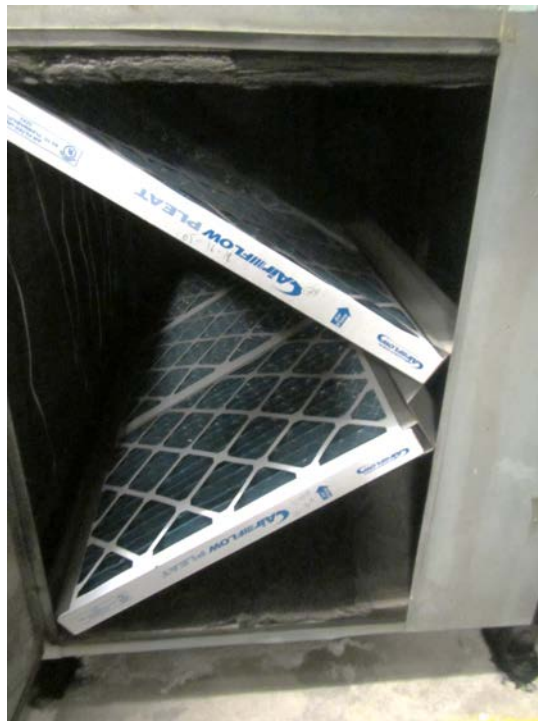
Picture 2

Pleated filters installed into air-handling unit

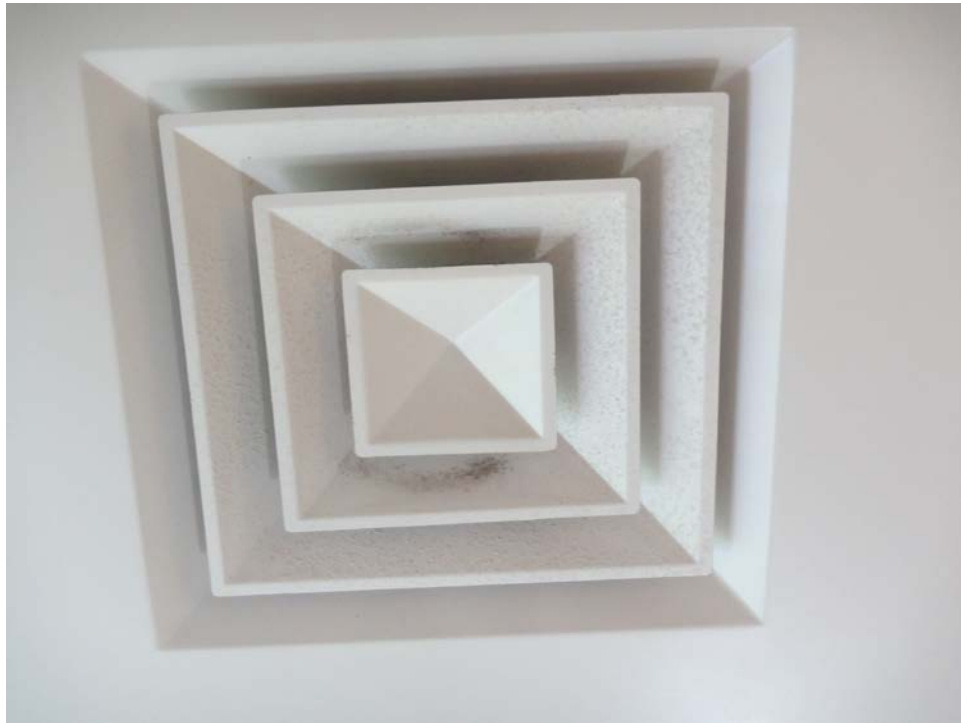
Picture 3

Dust was observed on a number of air supply and return diffusers (Picture 3; Table 1). Dust can be attracted to air supply vents because of the charge transferred to the metal diffuser when air is propelled out of the vent at high velocity. Dust can accumulate on return vents as air is being removed from a room. Accumulated dust can dislodge and recirculate in the air, becoming a source for respiratory irritation. Furthermore, dust can be a source for mold growth if it becomes wet over time. Vents should be cleaned of dust periodically to prevent accumulation and potential for mold growth.

Fresh air supply diffuser, note dust accumulation on vent

4. Examine the AHUs that service the DA's office areas to ensure adequate supply and exhaust ventilation and improve comfort.
5. Clean air diffusers regularly of dust and debris to prevent mold growth.

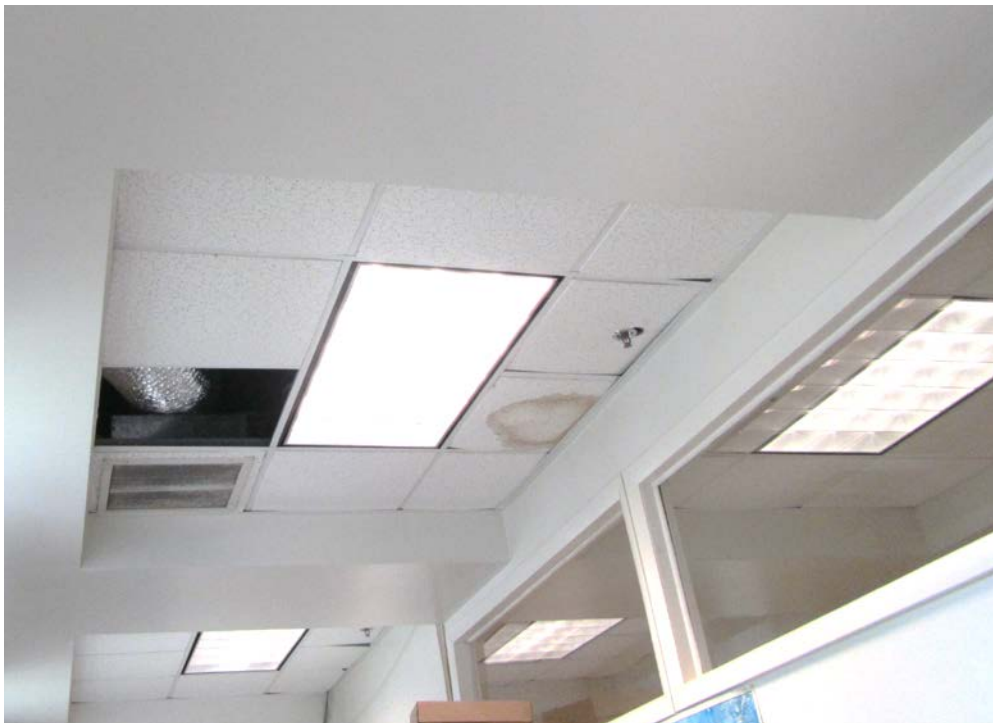
Picture 4

The WRC had water-damaged, missing and ajar ceiling tiles in a number of areas (Picture 4; Table 1), which may be from plumbing or building envelope leaks. Leaks should be repaired and pipes should be fitted with appropriate R-rated insulation to prevent condensation from occurring. Water-damaged ceiling tiles should be replaced once the water source has been fixed. During the replacement, the area above the ceiling tile system should be checked for any additional water damage or odors and cleaned or repaired as needed.

Exhaust vent occluded with dust. Note water-damaged and missing ceiling tiles

7. Ensure building envelope/plumbing leaks are repaired and remove/replace ceiling tiles that show signs of water staining or mold growth.
8. Examine water damage around windows. Repoint and repair to prevent continued damage.

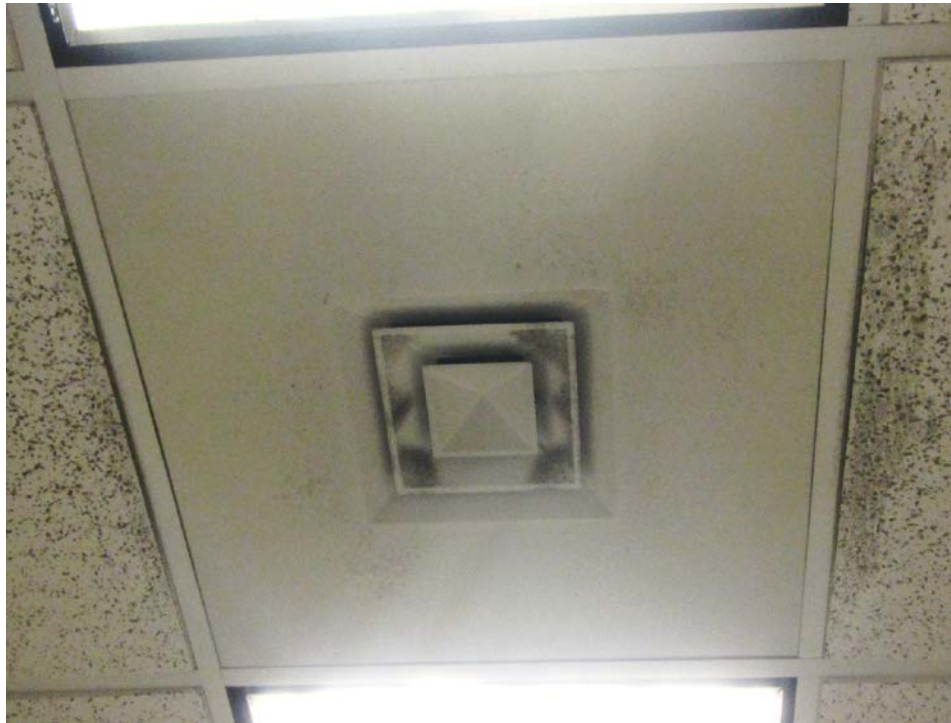
Picture 5

Evidence of condensation-related issues on building materials consistent with mold growth was observed by IAQ staff on supply vents and ceiling GW (Pictures 5 and 6). The type of observed damage suggests that water was condensing on metal air diffuser surfaces and the ceiling in proximity to the diffusers. Moisture can condense when the air conditioning system chills the metal supply diffusers in excessive humid weather. Dust and debris adhered to ceiling tiles or build up on air vents may become a source of material on which mold can grow.

Dust and potential mold growth on supply diffuser and ceiling tiles

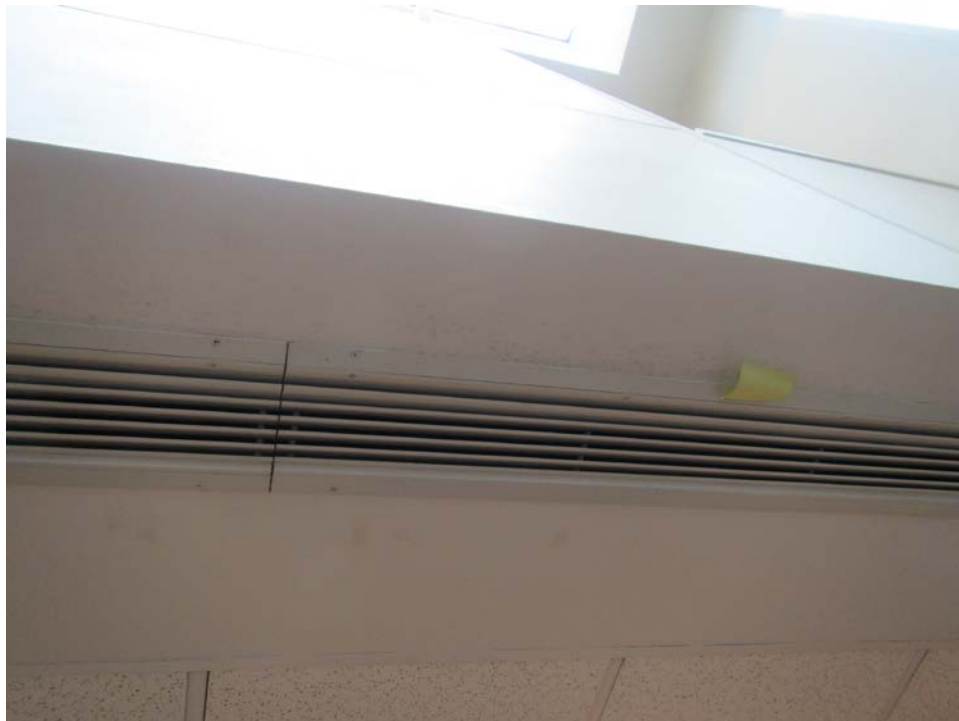
Picture 6

Condensation-related damage and mold growth was observed on GW around ceiling-mounted supply vents. At the time of the assessment, BEH/IAQ staff suggested that GW be

Mold growth on ceiling on either sides of supply diffuser

replaced with a mold resistant material (e.g., cement board or similar material) in impacted areas. Correspondence from Michael Lane, AOTC Environmental, Health & Safety Manager, reported that moldy GW was removed on October 3, 2018 after close of business.

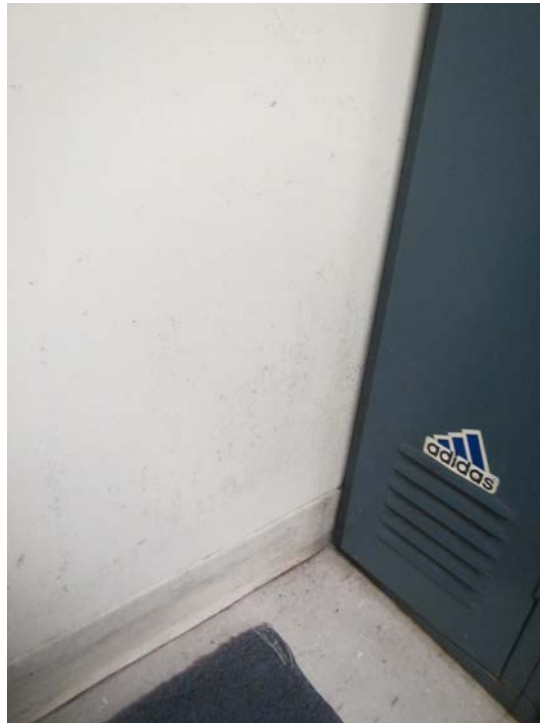
Picture 7

IAQ staff observed mold growth on a wall in the locker room outside of the Control Room (Picture 7). Growth in this area was also associated with the aforementioned humidity events. Considering the location of mold growth, the process of mopping with moisture wicking up the wall material can also contribute to increased mold growth in the area. As with other impacted areas, these walls should be removed and replaced with cement board.

Mold growth on wall of locker room

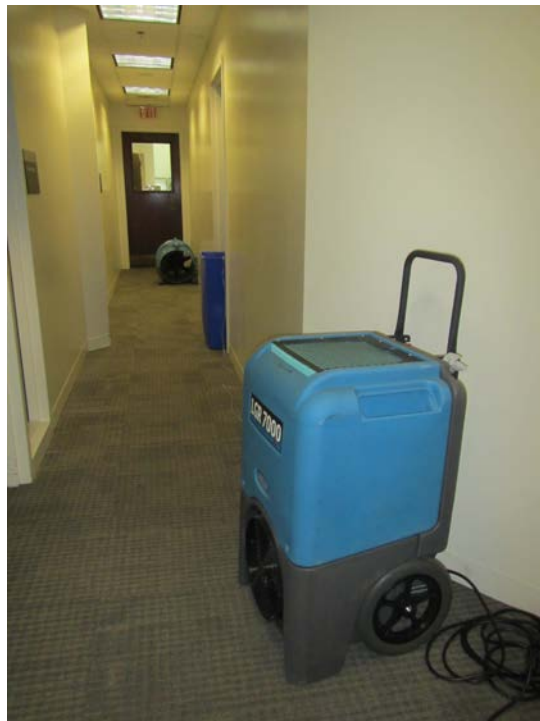
Picture 8

BEH/IAQ staff observed industrial dehumidifiers (Picture 8) in the basement space, which were not operating at the time of the assessment due to reported noise. Dehumidifiers must be maintained in accordance with manufacturer's instructions including drainage and cleaning.

Industrial dehumidifier (not operating at time of assessment)

3. Use dehumidifiers regularly to remove moisture from the space. Consider purchasing additional units for use during periods of sustained high humidity. Ensure all units are maintained in accordance with manufacturer's instructions including drainage and cleaning.

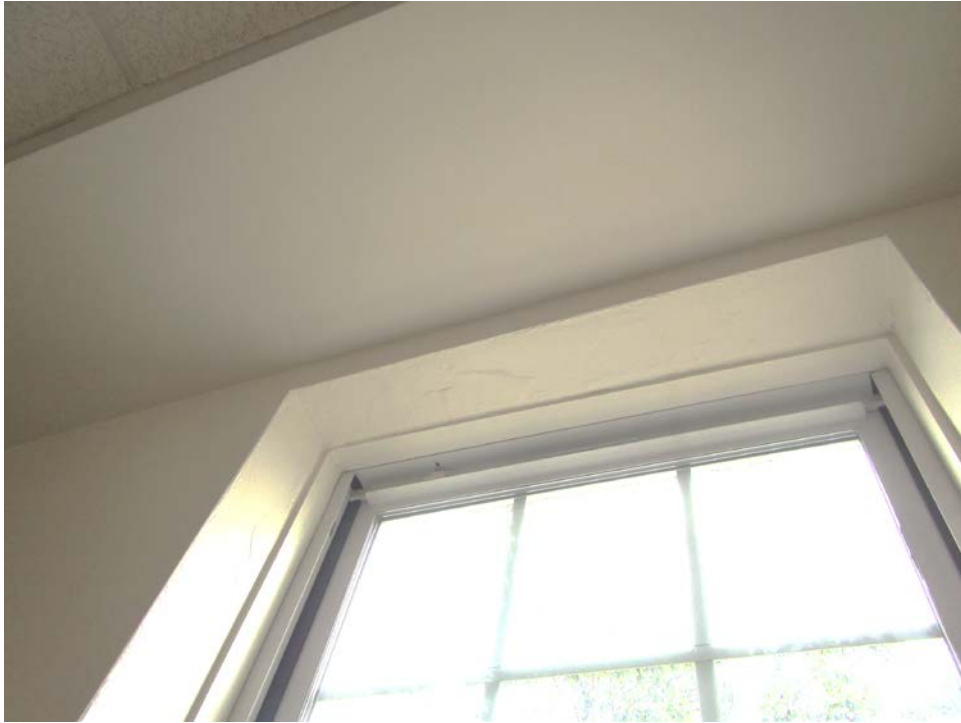
Picture 9

Damaged and bubbling paint was observed around windows in a few areas (Pictures 9 and 10), which suggests water intrusion around the window frame. Measures should be taken to identify the cause of the leak. These areas should be examined and remediated following repair of the leak.

Water-damaged paint around window

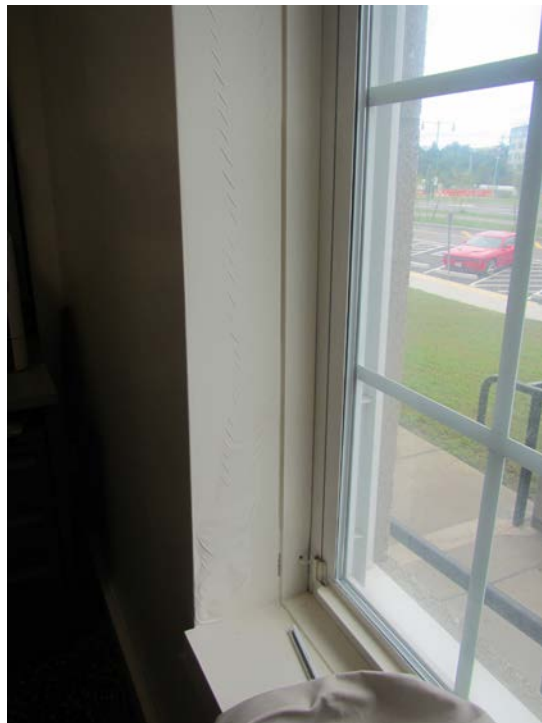
Picture 10

Water-damaged paint around window

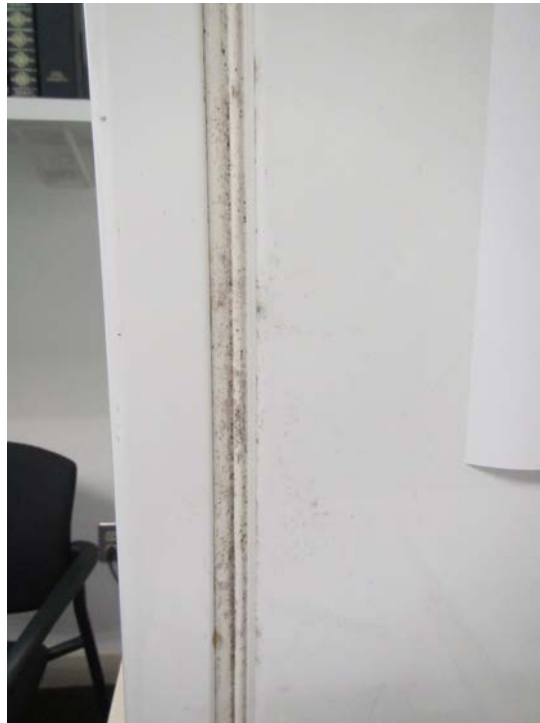
Picture 11

Mold growth was observed in refrigerator gaskets (Picture 11). Condensation on debris collected in gaskets is a common source of mold growth. Gaskets are also prone to bacterial growth. Cleaning gaskets periodically can prevent debris buildup and subsequent mold growth, as well as bacteria proliferation. If gaskets are too damaged to clean, they can be replaced.

Mold growth around refrigerator gasket

11. Clean refrigerator interior and gaskets periodically to prevent mold growth and any potential for food contamination.
12. Have carpet in basement spaces professionally cleaned. If they are beyond their service life, replace carpet with vinyl composition floor tiles. Floor tiles are resistant to moisture.

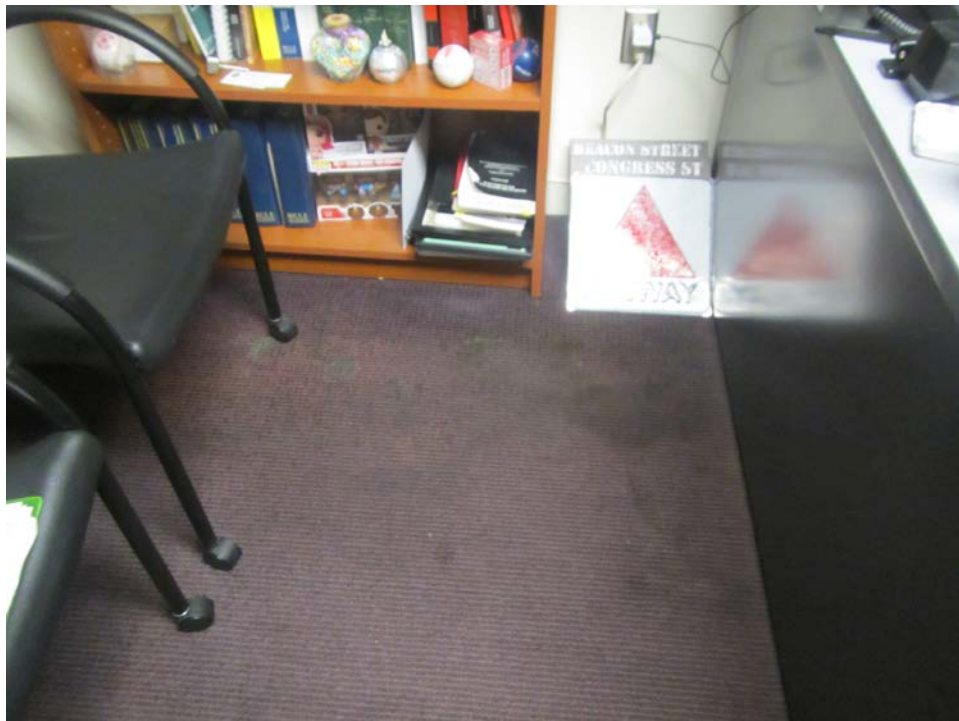
Picture 12

Stains from leaks and spills were observed on carpet in the basement level (Picture 12). In some instances, stains were the result of leaks from heating elements (Picture 13). Carpeting moistened periodically will be subject to microbial growth. In many instances, particularly in the DA's office, carpet appeared visibly stained, wrinkled, or threadbare, indicating it is past its service life. The service life of carpeting is approximately 10-11 years (IICRC, 2002). Aging carpet can produce fibers that can be irritating to the respiratory system. In addition, tears or lifting carpet can create tripping hazards. Carpeting should be cleaned annually or semi-annually in soiled high traffic areas (IICRC, 2012).

Stained and damaged carpet

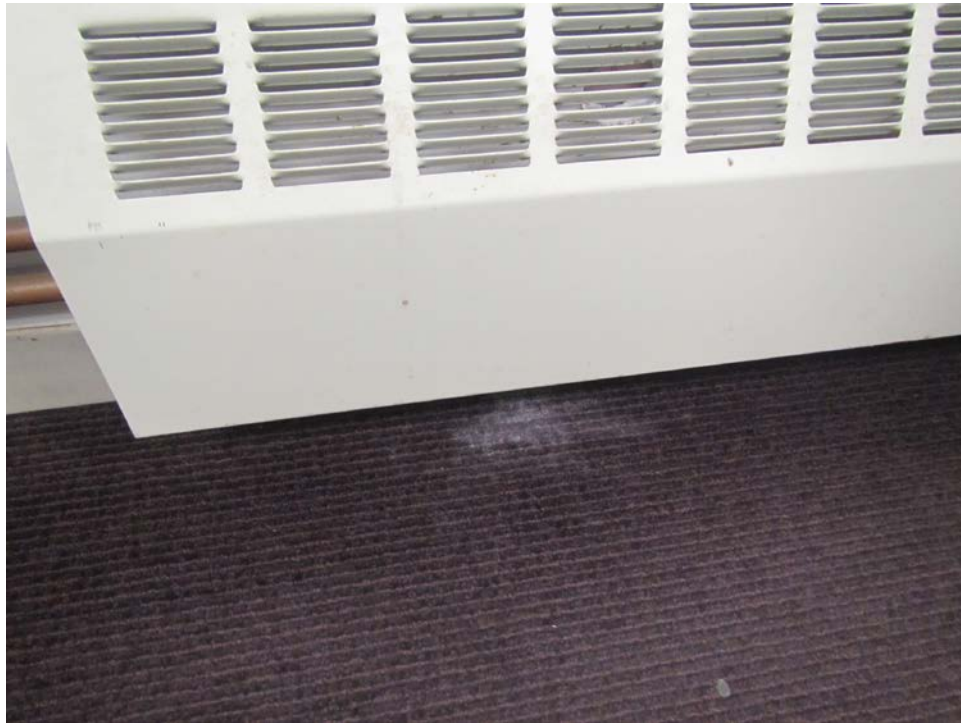
Picture 13

Water-damaged carpet

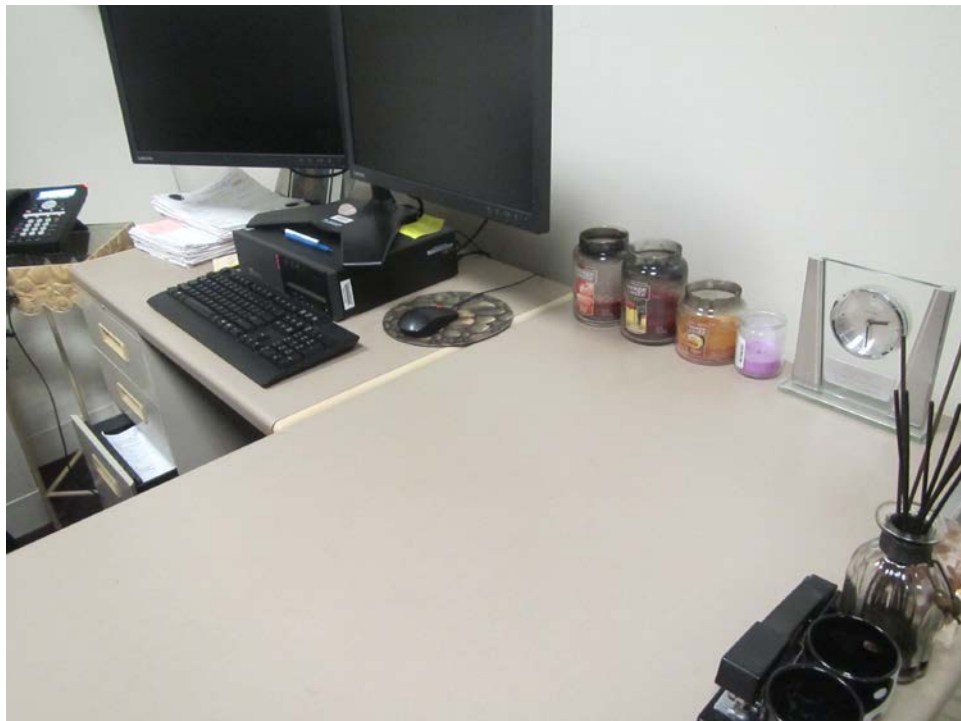
Picture 14

Additionally, air deodorizers and scented candles were observed in office spaces (Picture 14). Air fresheners and deodorizers contain chemicals that can be irritating to the eyes, nose, and throat of sensitive individuals. Deodorizing agents do not remove materials causing odors, but rather mask odors that may be present in the area. Furthermore, candles present a fire hazard.

Scented candles in office

13. Reduce use of products and equipment that contain VOCs.
14. Remove candles from office to prevent fire hazard.
15. Ensure flat surfaces are cleaned periodically to prevent buildup of dust, which can serve as a source for mold growth. Reduce the number of items stored on flat surfaces.
